Satellite Sentinel Project

Situation Report: Explosions in Khartoum, Sudan

October 26, 2012

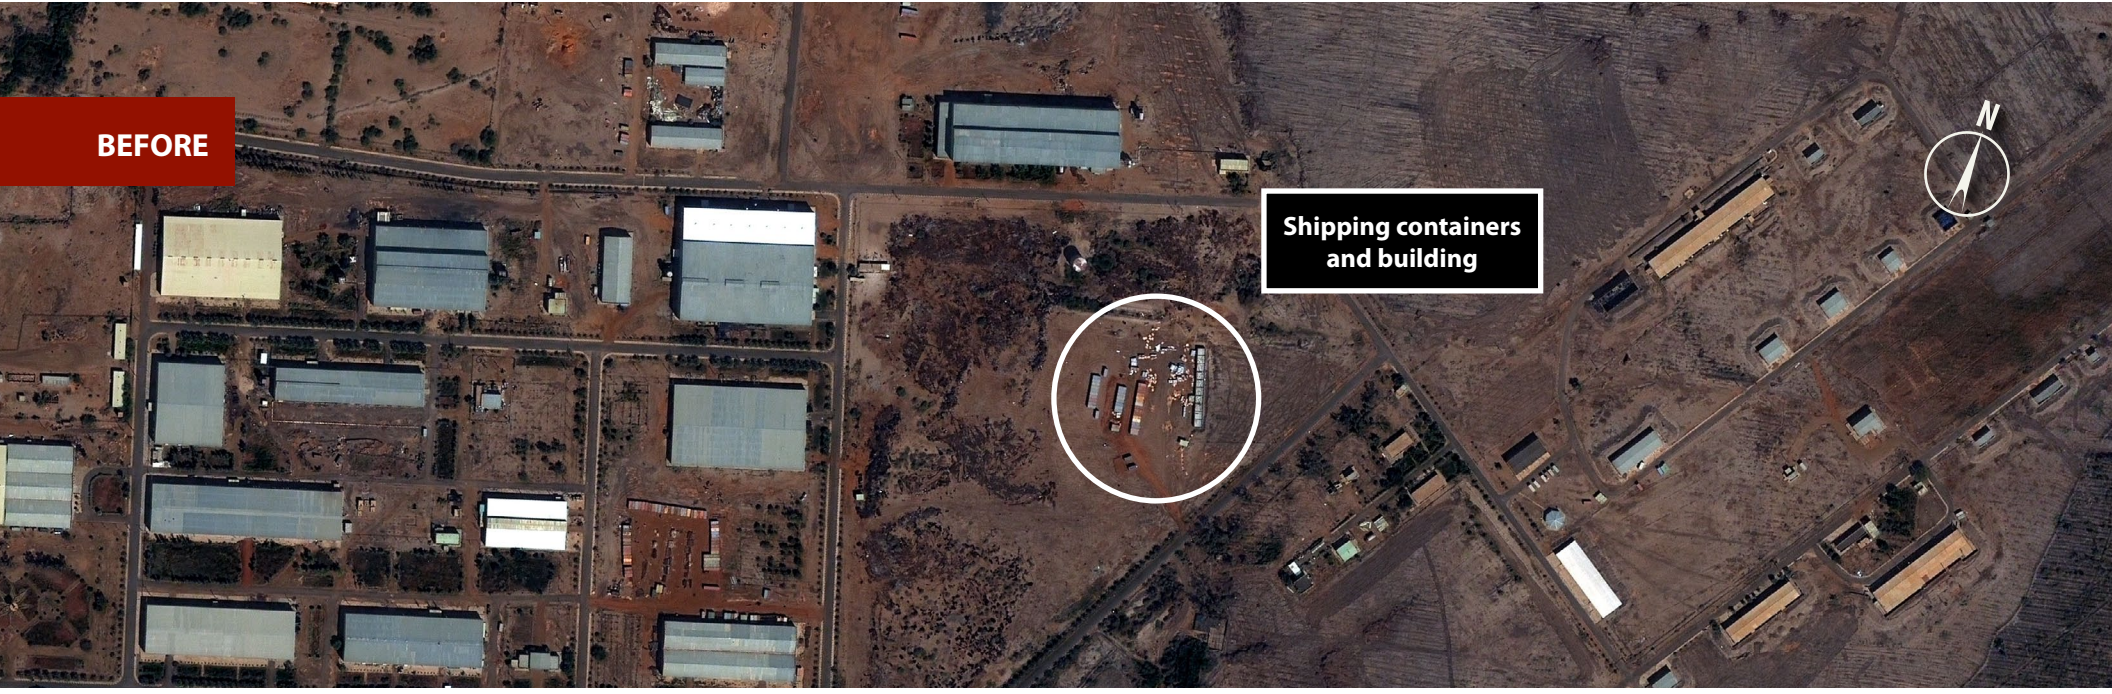
BEFORE

Shipping containers
and building

Explosion Site, Yarmouk Military Depot, Khartoum, Sudan
DigitalGlobe Natural Color Image, October 12, 2012 (Upper Image)

The explosions were centered on a site that, as recently as October 12, consisted of a 60-meter-long, shed-type building and approximately 40 shipping containers, each 6.5 meters long, stacked nearby. The October 25 image reveals evidence of massive explosions at this site and no evidence remains of the 60-meter-long building or the shipping containers. While SSP cannot confirm that the shipping containers seen on October 12 remained at the site on October 24, analysis of the imagery is consistent with the presence of highly volatile cargo in the epicenter of the explosions.

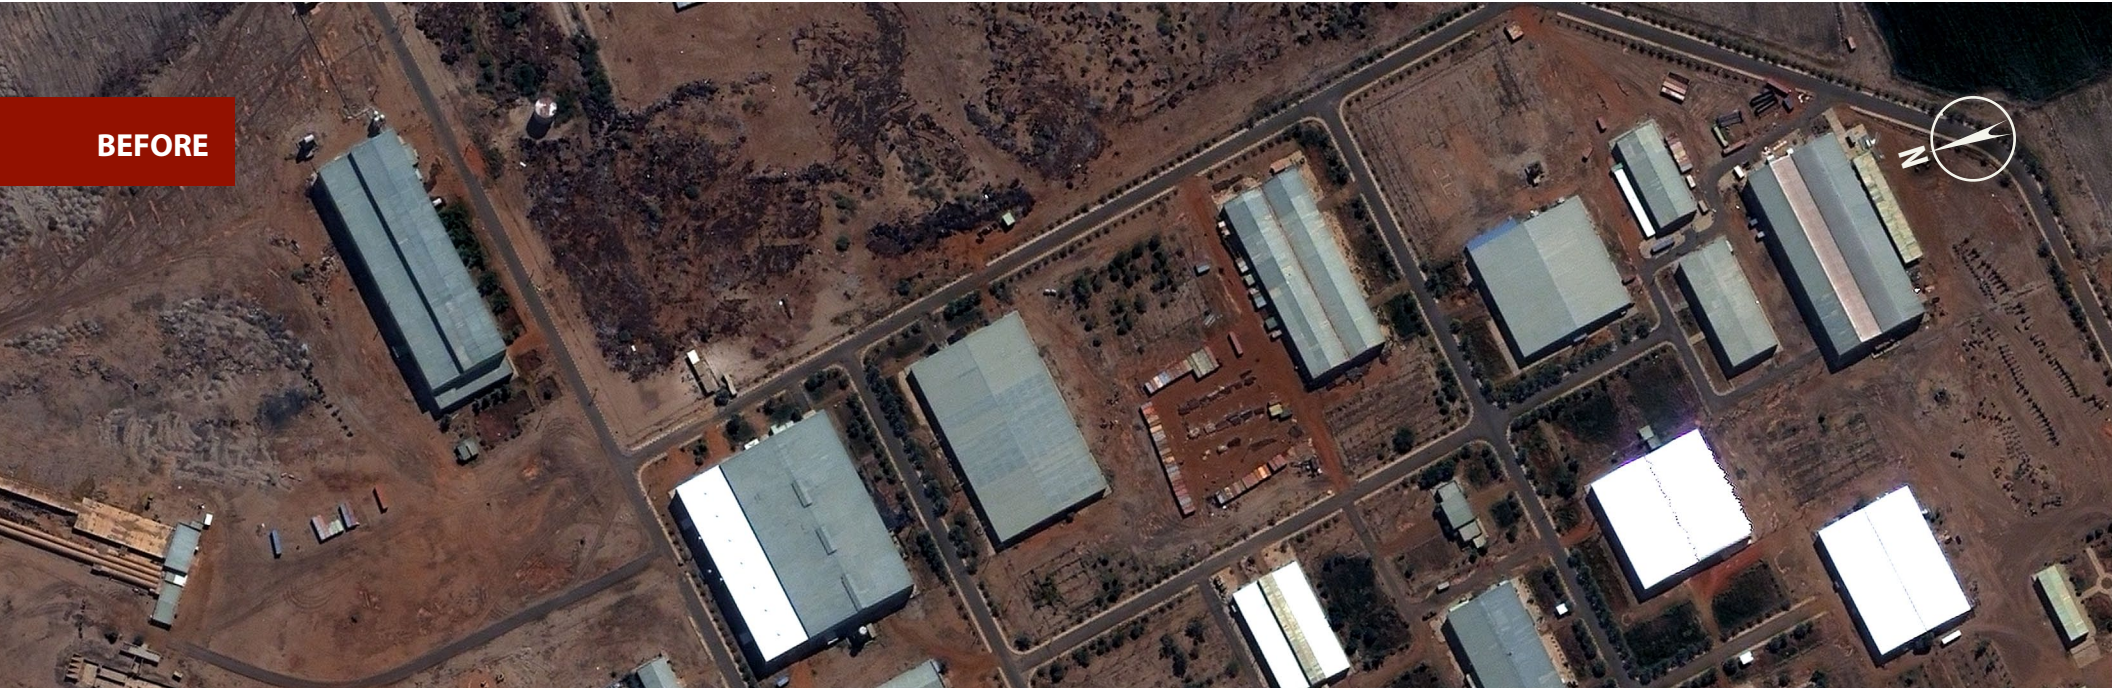
BEFORE

Yarmouk Military Depot, Khartoum, Sudan

DigitalGlobe Natural Color Image, October 12, 2012 (Upper Image)
